Property ID:	153	Date: 8-16-03
Address:	3332 LAFAYETTE	Telephone #:
Inspector/Assessor:	CO Certification #: 12860

LBP Assessment Results

Property ID # 153 / 3332 Lafayette

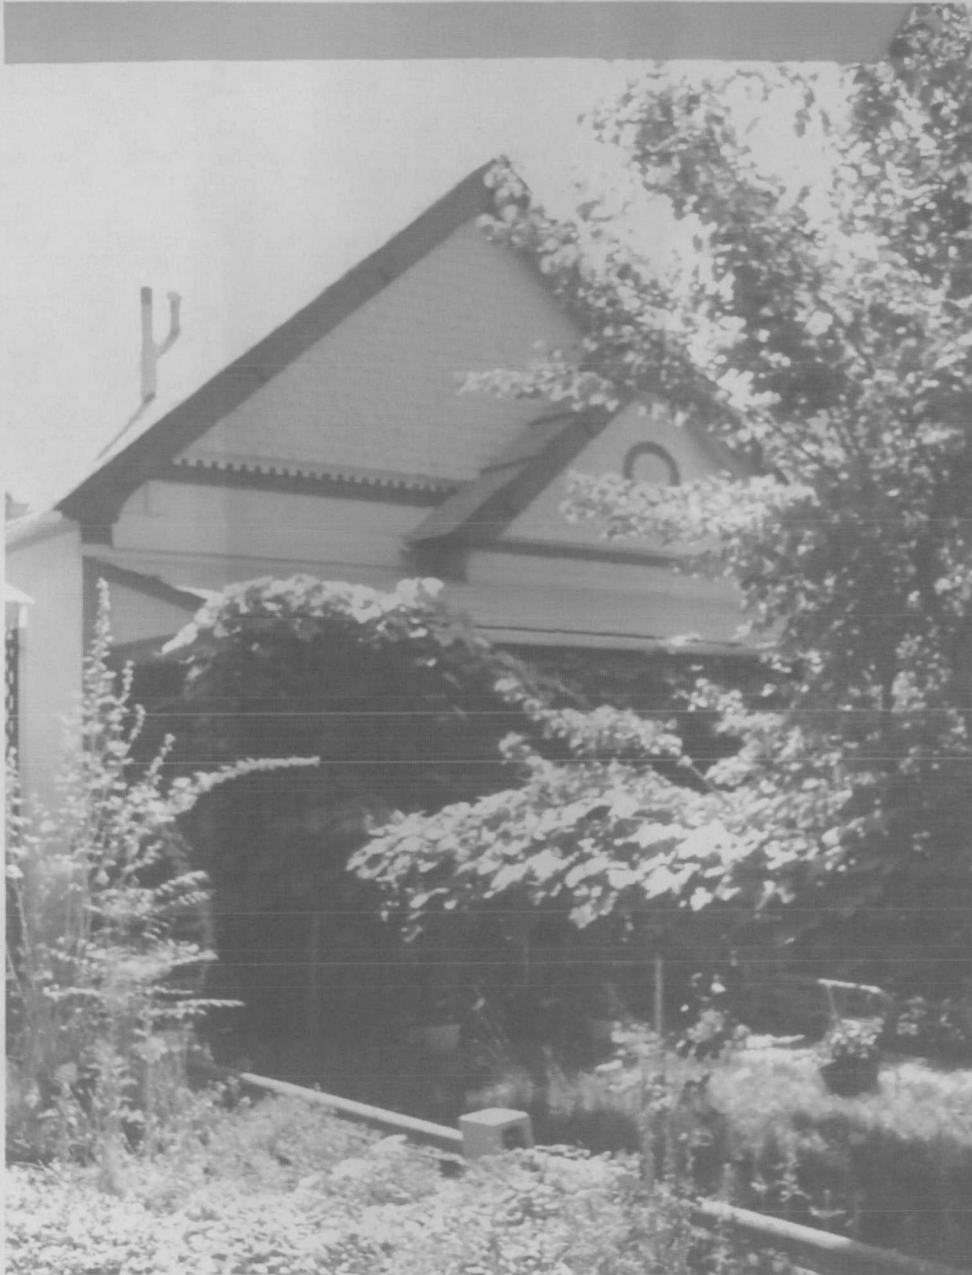
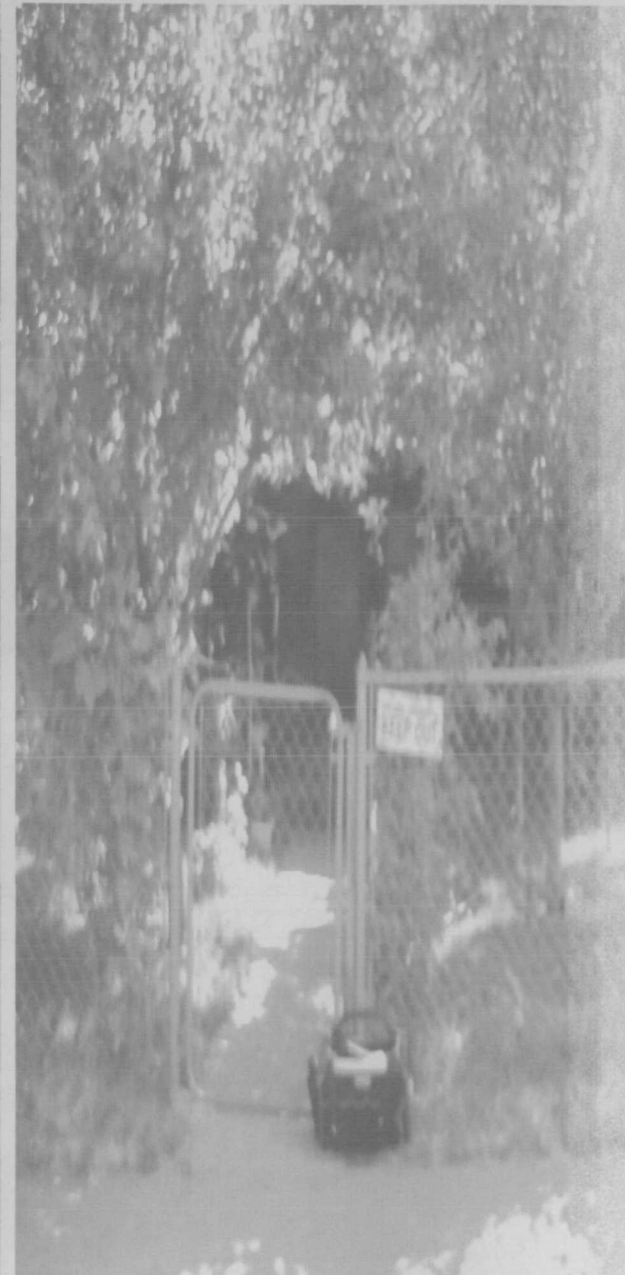
West exposure of property
